COMMONWEALTH OF KENTUCKY
BEFORE THE PUBLIC SERVICE COMMISSION

AN INVESTIGATION OF SOUTH CENTRAL BELL)	
TELEPHONE COMPANY, LESLIE COUNTY)	
TELEPHONE COMPANY, INC. AND GTE SOUTH)	
INCORPORATED)	CASE NO. 94-390
)	
<hr style="width:50%; margin-left:0"/>		
ALLEGED FAILURE TO COMPLY WITH)	
COMMISSION REGULATION 807 KAR 5:006)

ACCIDENT REPORT
SCB Tower Collapse

Preliminary Failure Evaluation
MICROWAVE REPEATER TOWER GLC 52341
Jackson, Kentucky
Law Engineering Project Number 712.94.896

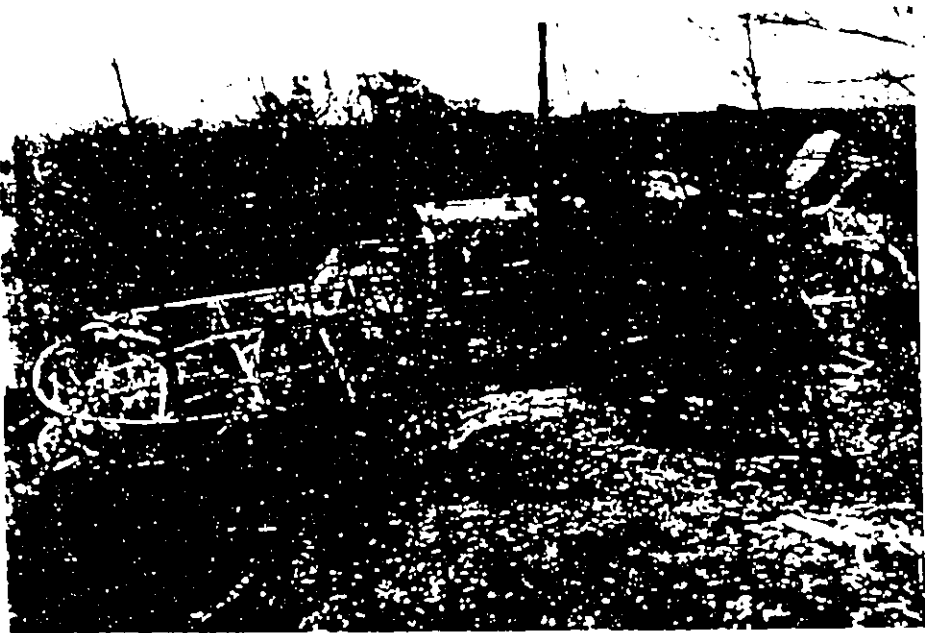
Looking down road at
tower in distance
